## Appendix C: Sensor Installation Details

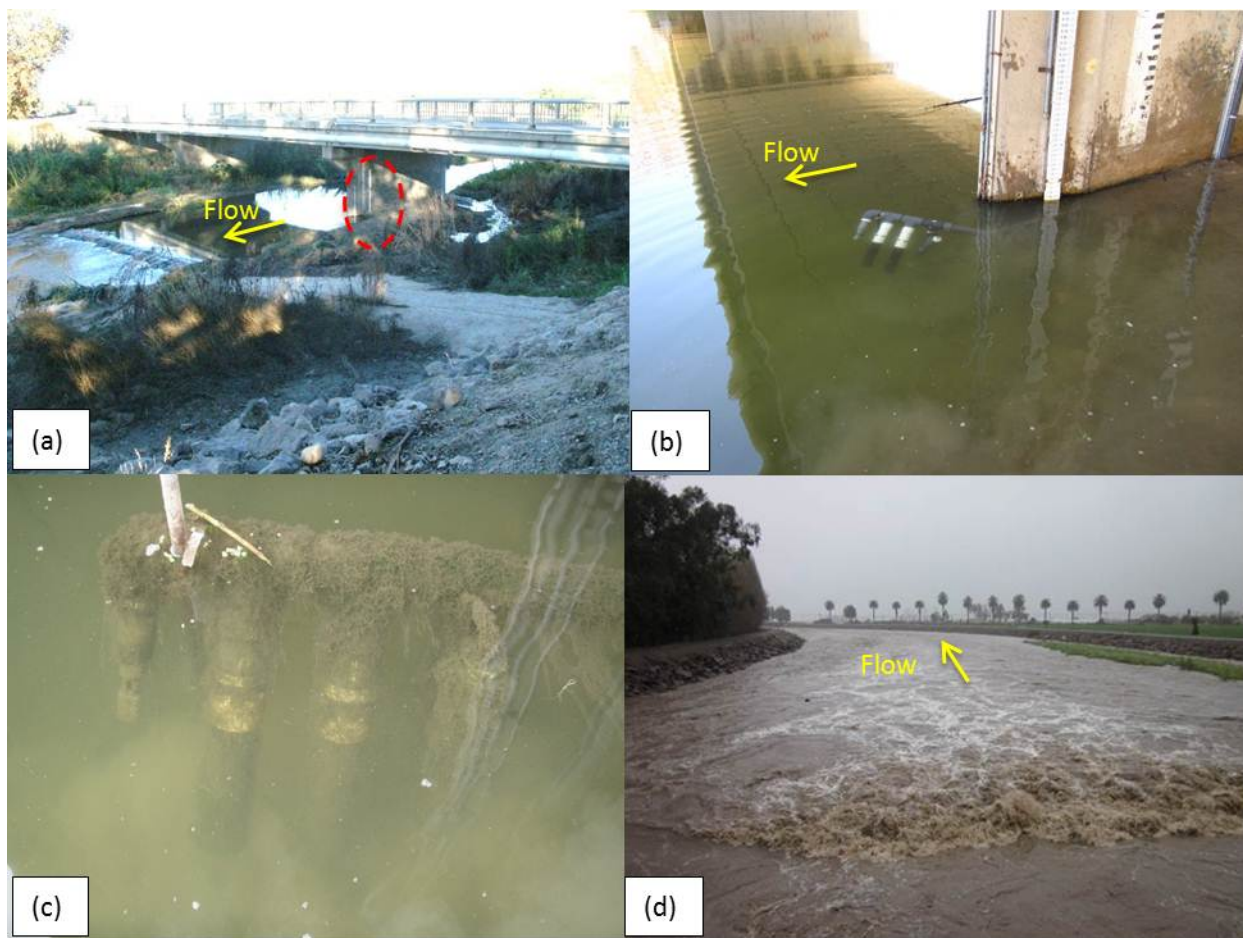
**Figure 1. Sensor system at 03\_UNIV: (a) Sensor unit attached to bridge pier, downstream drop structure; (b) Salts sensors suspended in pool downstream of pier; (c) Submerged sensors with two weeks of fouling; (d) March 20, 2011 storm flow looking downstream.**

The 03\_UNIV station is co-located with USGS and Ventura County Watershed Protection District (VCWPD) equipment on Calleguas Creek under the University Drive Bridge. The electronics housing is bolted securely to a relatively protected side of a bridge pier. Two inch SCH 80 PVC conduit drops six feet vertically to below water level and then extends horizontally to position the salts sensors in the creek. While this creek section is shallow with significant moving sand, the bridge pier creates a relatively protected and stable 1.5 foot deep pool just downstream of the pier, providing an ideal location for the salts sensors. For salts, the station is equipped with two EC sensors (standard, non-contact), and four chloride ion selective electrode sensors. For flow, a depth sensor is securely anchored next to the bridge pier at the bottom of the vertical PVC section; the horizontal PVC section creates a stilling well. A concrete drop structure seen in Fig A1(a) just downstream provides some improved channel stability for flow ratings.

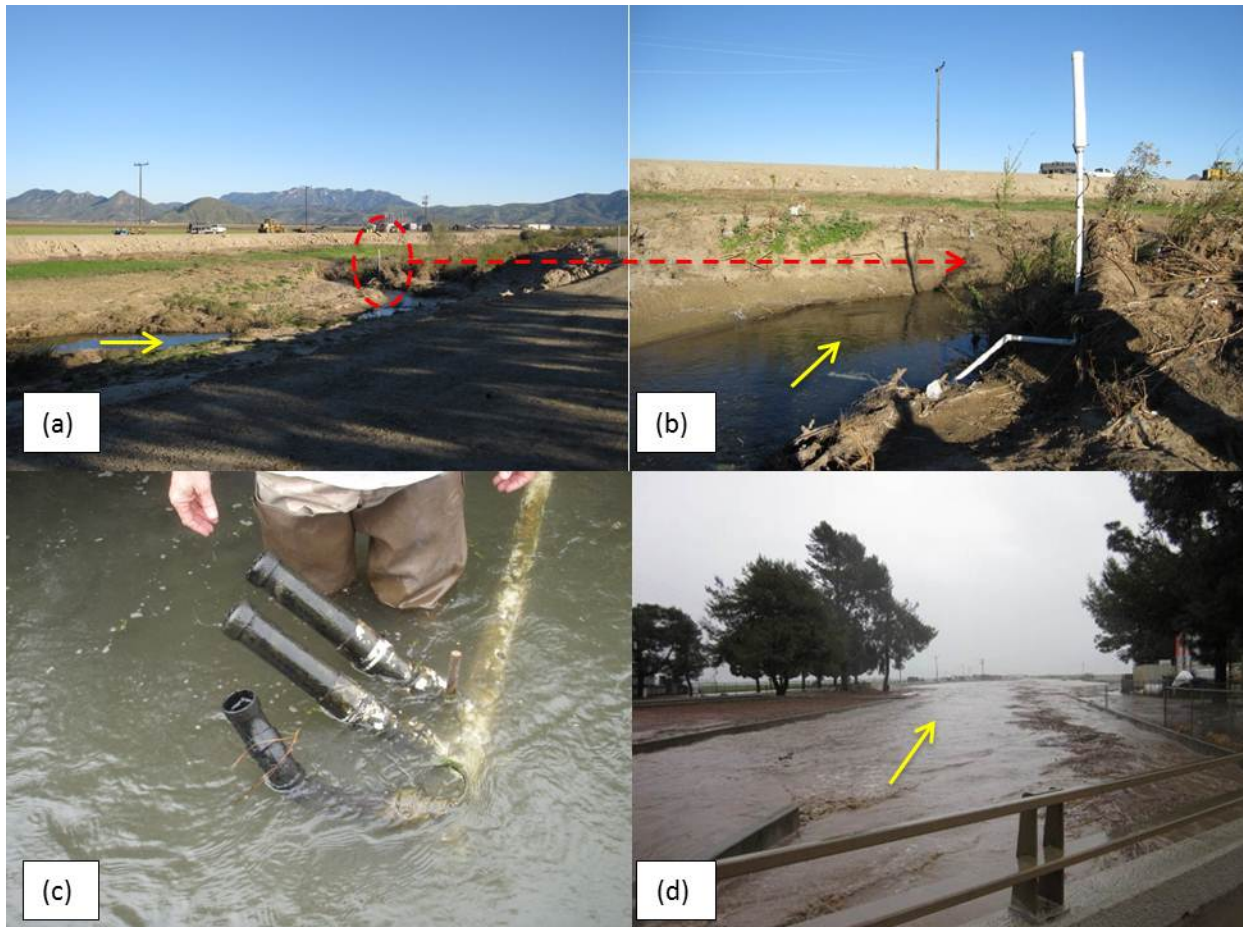
**Figure 2. Sensor system at 04\_WOOD: (a) Revlon Slough natural channel, looking downstream just below Wood Road; (b) Sensor unit is staked in roots and dirt in middle of channel; (c) Sensors rotated up for maintenance; (d) March 20, 2011 storm flow looking downstream from Wood road.**

The 04\_WOOD site is located on Revlon Slough 200 yards downstream of Wood Road where the channel transitions from concrete-lined to natural. 4\_WOOD is the most challenging site for deployment of continuous sensors, and initial attempts to monitor in the concrete channel during a pilot study in 2009 were unsuccessful due to rapid deposition of silt and lack of salts uniformity across the transect. The present location was selected because the creek is narrow and deep with a hard pan bottom, indicating that the swift water tends to scour rather than deposit silt. The system is staked in root balls in the middle of the channel where it is at some risk but survived the March 20, 2011 storm intact, reducing urgency to find a safer location. The sensors are positioned in the middle of the creek using 2-inch PVC conduit secured by metal stakes driven into the substrate. The creek is typically 1.5 feet deep at the sensor location. For salts, the station is equipped with one EC sensor and four chloride ion selective electrode sensors. For flow, a depth sensor is located closer to the electronics unit and the conduit is secured to prevent movement by clamping between pairs of 4 foot metal stakes driven into the creek bed.

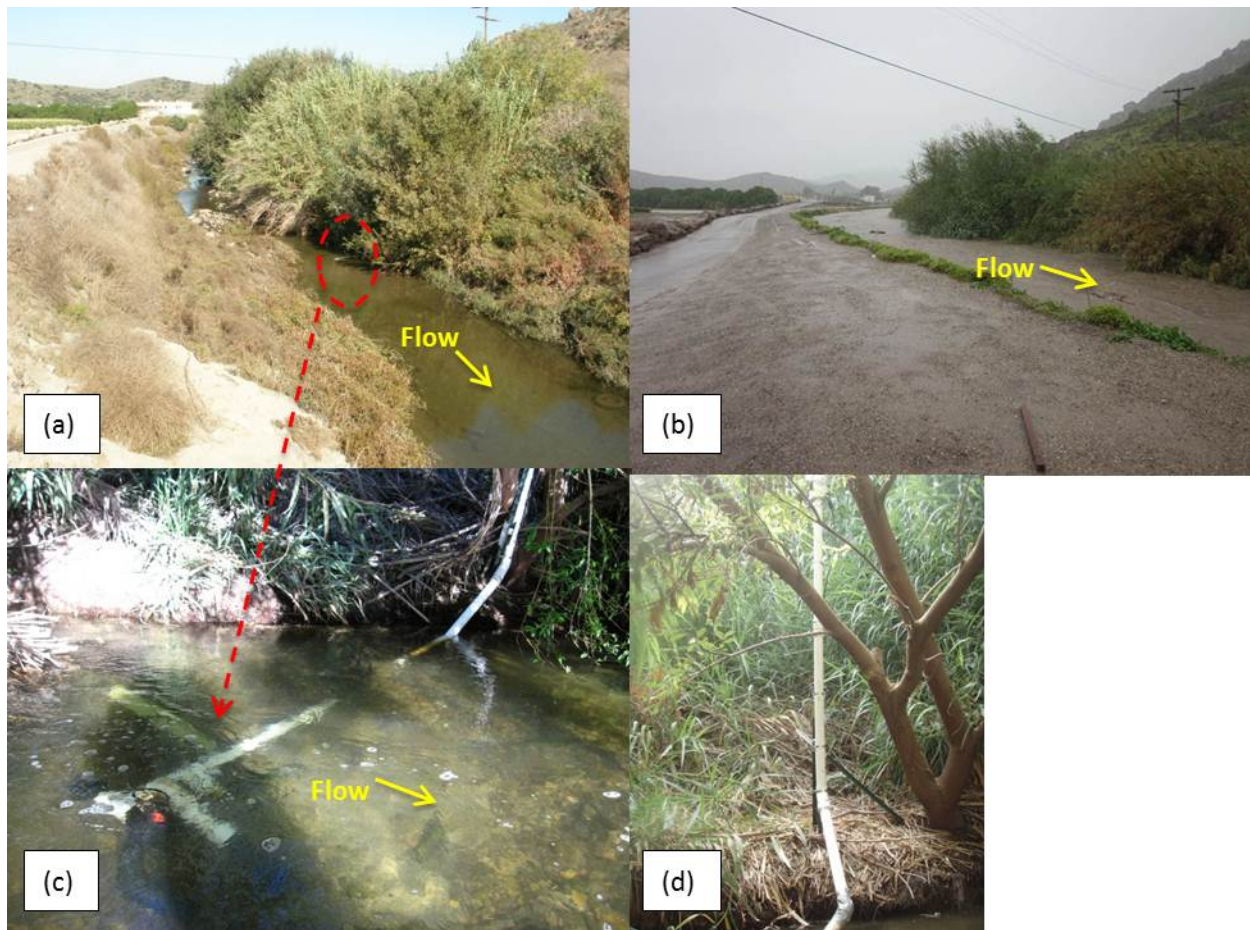
**Figure 3. Sensor system at 9A\_HOWAR: (a) Conejo Creek looking upstream near Howard Road toward Camarillo WRP; (b) March 20, 2011 storm flow looking upstream from similar location; (c) Sensors staked and supported in channel in PVC conduit; (d) Electronics housing staked on river bank.**

The 9A\_HOWAR site is located on Conejo Creek 50 yards upstream of Howard Road (downstream of the Camarillo WRP). The electronics housing was originally attached to a tree, but was moved to metal stakes after the tree became unstable following the March 20 storm. Two inch PVC conduit secured by metal stakes positions sensors in the middle of the creek. The creek is typically one foot deep at the sensor location, although the bottom is sandy and depth alters some with storms. For salts, the station is equipped with one EC sensor and two chloride ion selective electrode sensors. For flow, a depth sensor is located close to the river bank, and the conduit is secured to prevent movement by clamping between pairs of 4 foot metal stakes driven into the creek bed.

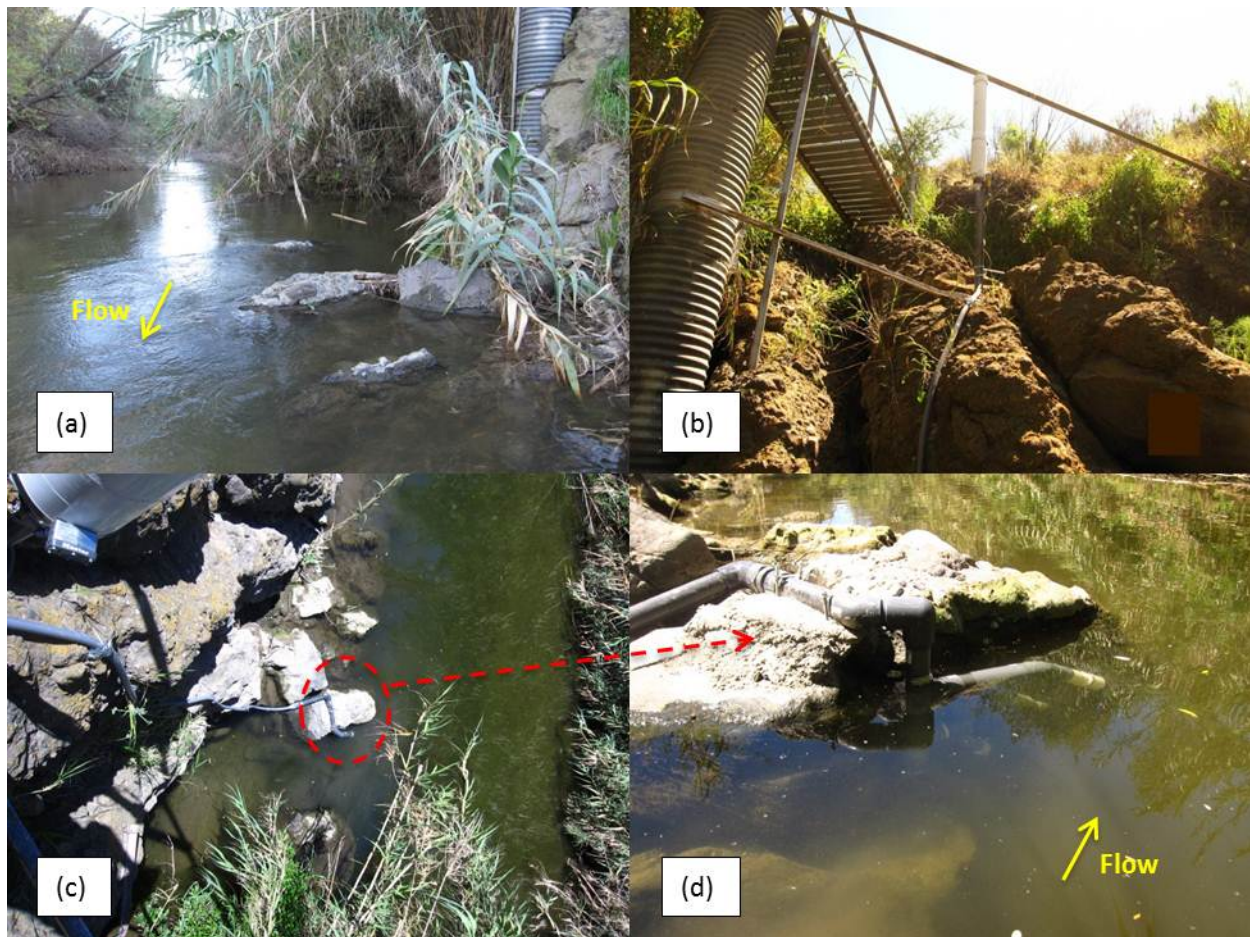
Figure 4. Sensor system at 9B\_BARON: (a) Conejo Creek at county gage station, looking upstream; (b) Electronics housing attached to gage station structure; (c) View looking down from electronics housing location to sensor location in creek; (d) Sensors positioned against upstream side of rock in deep protected pool.

The 9B\_BARON site is located on Conejo Creek at the VCWPD gaging station behind Baron Brother's Nursery. The electronics housing is secured to a preexisting steel support 15 feet above water level. One-inch diameter flexible conduit drops down to creek level, where two-inch SCH 80 conduit bolted to concrete positions sensors in the creek. The creek is typically a few feet deep at the sensor location, although the bottom is sandy and depth alters significantly with storms. For salts, the station is equipped with two EC sensors (standard, non-contact), and two chloride ion selective electrode sensors. For flow, a depth sensor is securely anchored in the vertical pipe that drops into the water and is configured with horizontal pipe to create a stilling well.

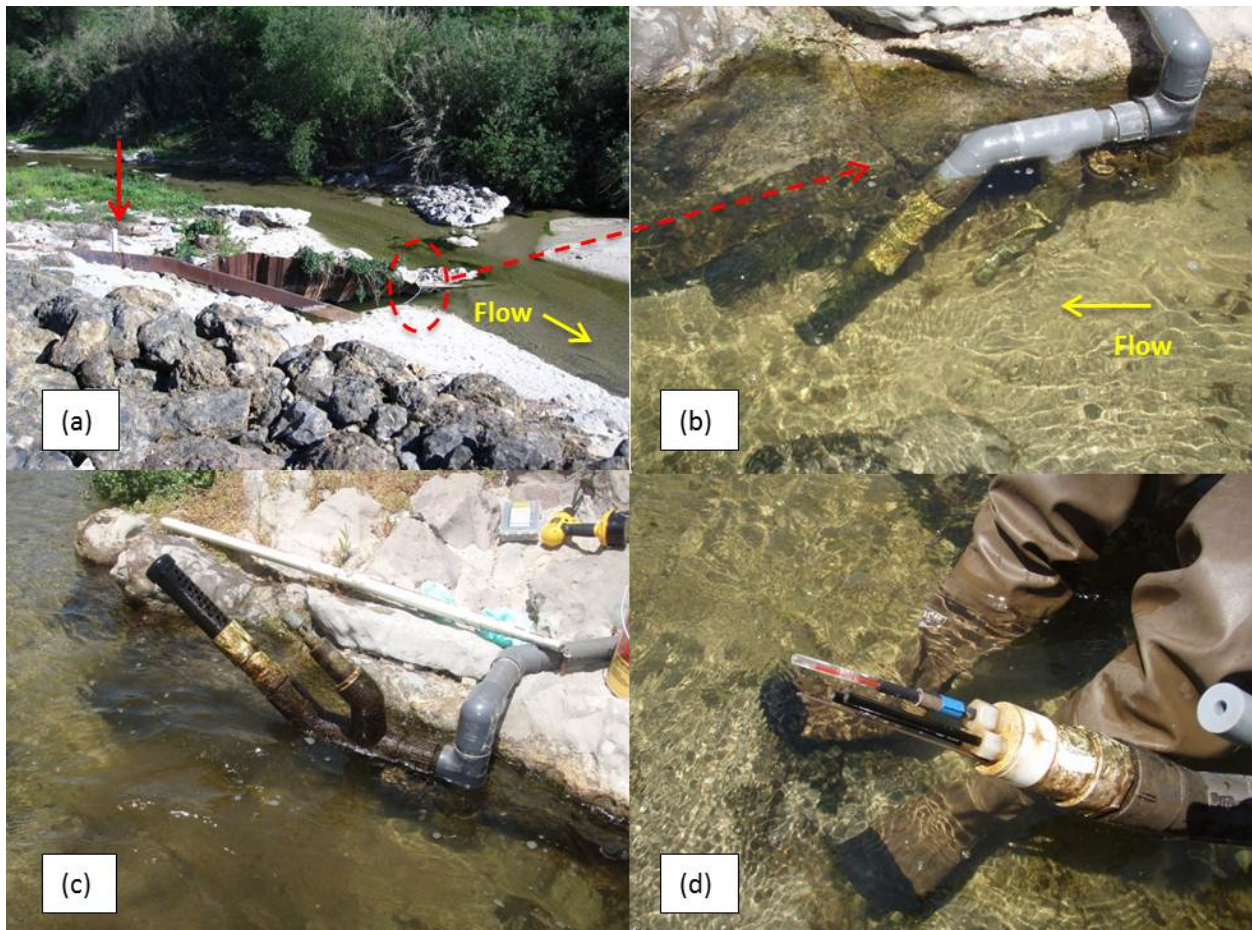
Figure 5. Sensor System at 07\_HITCH-S: (a) Arroyo Las Posas constricted by concrete and steel structure, electronics housing attached to I-beam on left is indicated by red arrow, flexible conduit runs to sensor location on concrete jutting into channel (red dashed circle); (b) Sensors anchored to near-vertical side of a boulder on upstream side of constriction; (c) Sensors rotated up out of water for maintenance; (d) Chloride sensor unit with shield removed to show sensing electrodes.

07\_HITCH-S is located on Arroyo Las Posas one mile upstream of Hitch Blvd. At the site, the channel is constricted by the concrete and steel ruins of what may be an old drop structure. This creates a narrower, deeper and more stable channel in what is otherwise a shallow, sandy, and meandering creek. The electronics housing is secured to a steel I-beam that runs up the bank of the channel. One-inch diameter flexible conduit runs 40 feet along the I-beam down to water level, where two inch SCH 80 PVC conduit bolted to concrete positions sensors in the creek. The creek is typically 1.5 feet deep with swift moving water at the sensor location, although the bottom is sandy and depth alters with storms. For salts, the station is equipped with two EC sensors (standard, non-contact), and two chloride ion selective electrode sensors. For flow, a depth sensor is securely anchored in the vertical pipe that drops into the water and is configured with a horizontal pipe to create a stilling well.
